## 1 Introduction

10<sup>th</sup> of May 2005 a tragic accident happened in Drammen, Norway during dismantling of a crane. Two persons died (29 and 48 years) when the counter-weight on the crane fell to the ground. This report gives a brief overview and experience learned from this accident. The report does not cover the way of work and procedures involved in the dismantling of the crane, it only covers the fall protection matters.

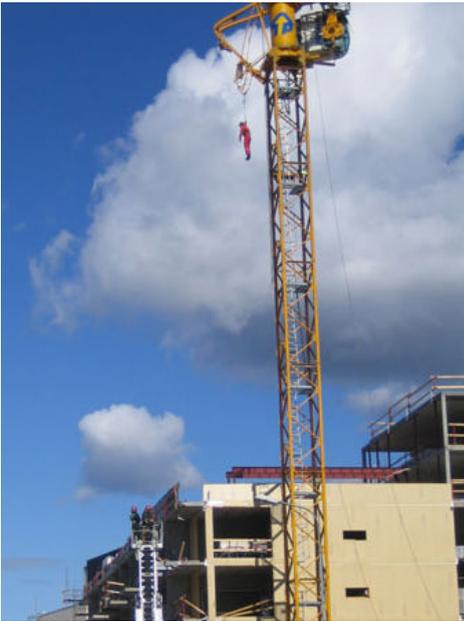
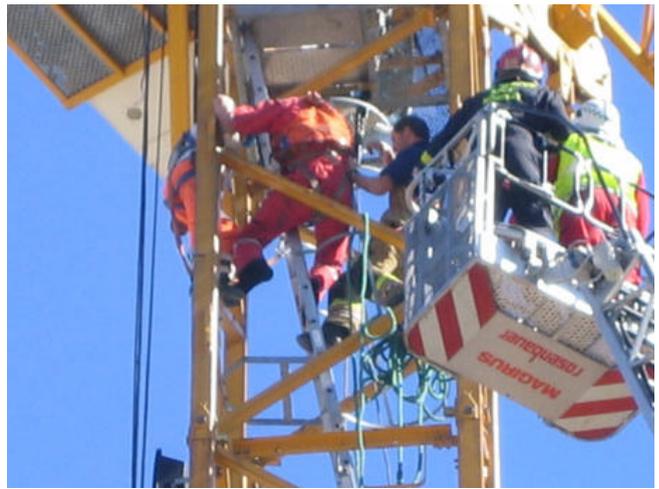
The accident happened when the counter weight beam (back-bridge) on the top of the crane should be removed. This came out of control and fell freely 40 metres to the ground, together with one of the workers. This worker was wearing a full body harness, but was not connected to any anchor. The back-bridge that fell, had a weight of 5 to 6 tons.

The other worker was working from a small platform with rails, which is a part of the crane construction. He was protected by a full body harness and lanyard connected to the hand rail of the platform. The lanyard did not have any kind of fall absorption and it was knotted onto the rail. The other end of the lanyard was connected to the harness back attachment.

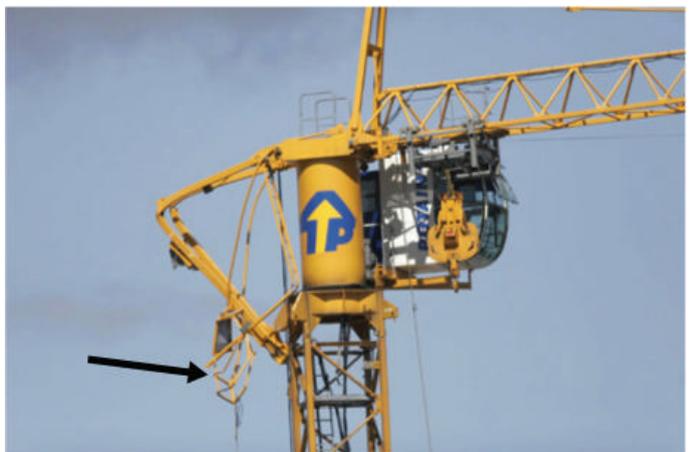
The construction that fell was integrated with the platform the worker was working from, and in the fall the weight of the back bridge bent the platform construction 90 degrees before they came apart (shown on the picture to the right with arrow towards the platform). The worker fell out of the platform, and it is estimated that he got a free fall (partly reduced by the friction in the bending construction) of between 8 and 10 metres including the length of his lanyard. He was then arrested by the harness, but without any shock absorption. It is not clear if he also collided with the main crane construction.

2. The lack of shock absorber was a serious mistake, and probably cause of the fatal injury to the 29 year old.
3. CEN should investigate full body harnesses with back attachment and waist strap. It is important to find out if the force on the body by the waist strap, during the arrest of falls by the back attachment is acceptable. This is not taken into account by free fall tests on a dummy.

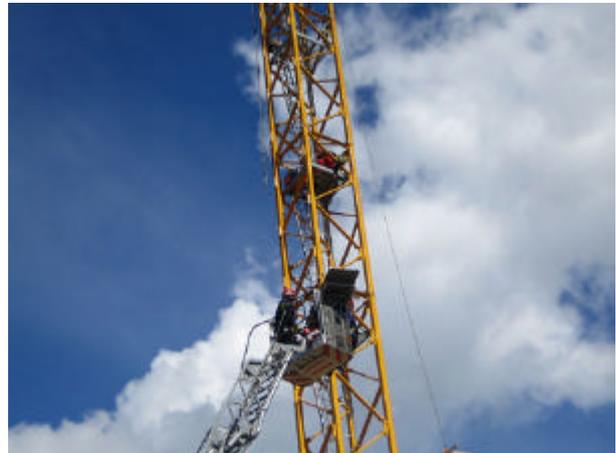
No rescue plan or equipment was available at the site. A rescue team from the Fire Department was quickly on site, but did not have long enough ladders to reach the person directly. The Police feared that the whole crane could fall down over neighbouring houses without the counter weight, and did not allow any rescue to be started in the crane before it was stabilized. This was done by a secondary crane, and in total the person was suspended in his harness for 25 minutes.

During the rescue the person was lowered inside the crane for about 10 metres, and then taken onto the ladder on the fire engine. He was transported horizontally on a stretcher, from where he was picked up by the ladder.

5. Although Suspension trauma was not the cause of death in this situation, it demonstrates that rescue personnel is not aware of this risk and transports the person horizontally. This was a classic situation where Suspension trauma could occur, and rescue personnel should be trained in correct rescue of persons suspended in a harness.
